HILTON HALL RSJ COLUMN REPAIRS AND CEILING SLAB / UNDER SOFFIT CONCRETE REPAIRS
Sponsored by Ni-Co Coaching Partnership

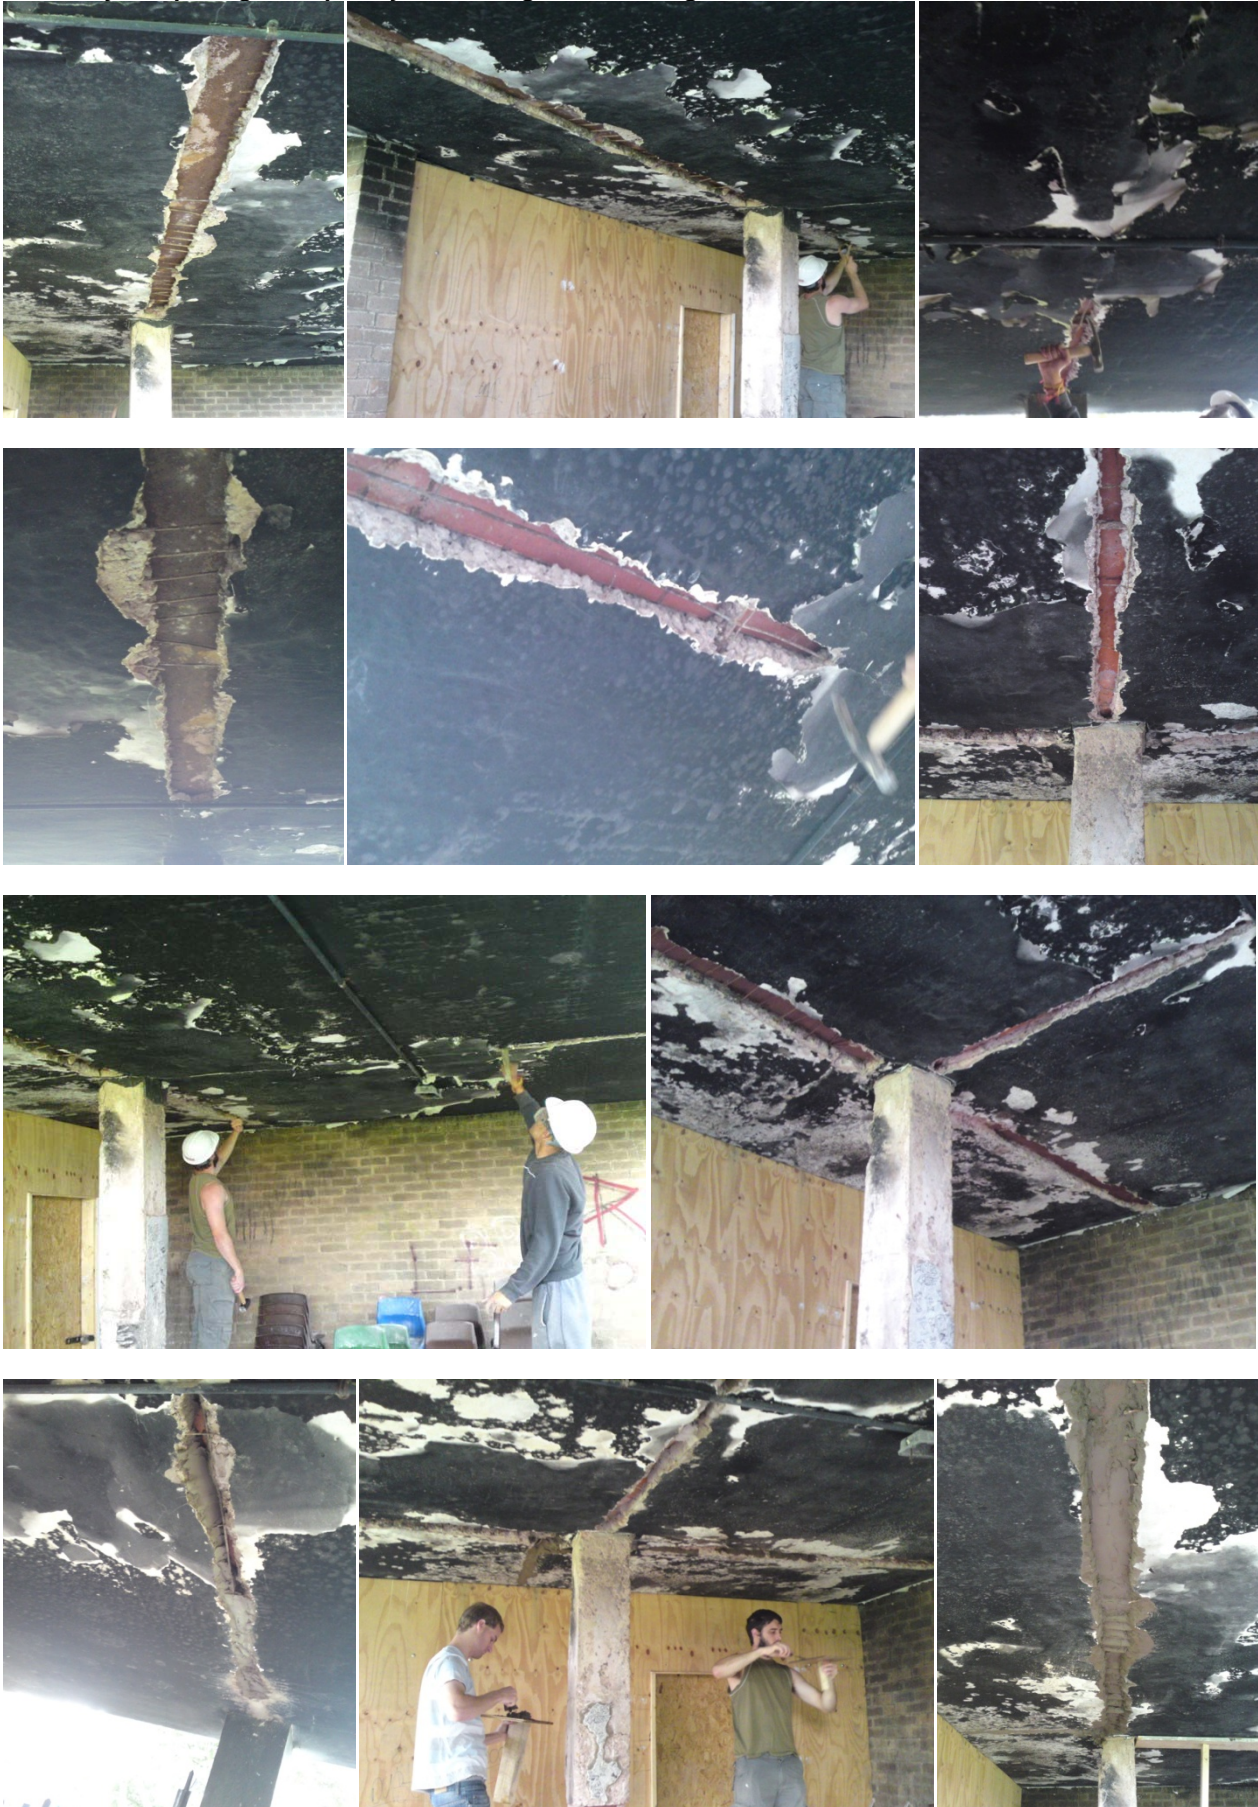
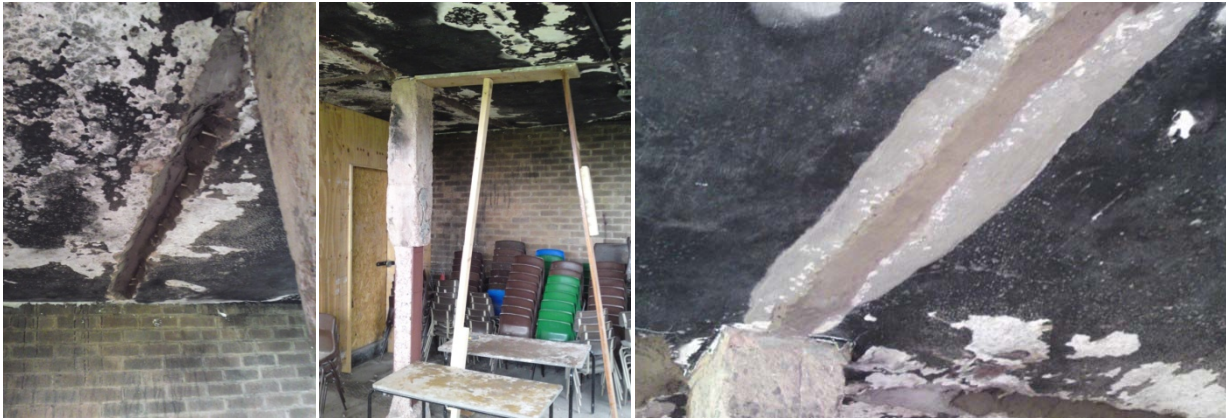
The following photographs show the extent of the fire damage caused (over eight years ago). Our team of volunteers Lead by Ni-Co Coaching Partnership Staff (who sponsored this part of the repair programme) chiselled away the loose damaged concrete (around the main structural RSJ Beams), repainted the RSJ's with red-oxide paint before applying PVA and finally completing the repair by 'Rendering' with a strong concrete mix.

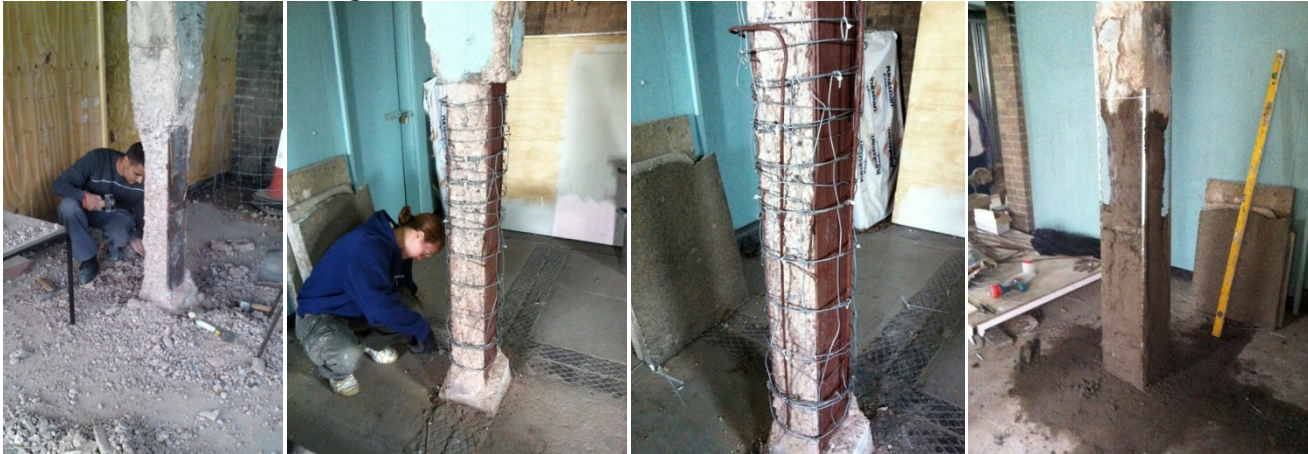
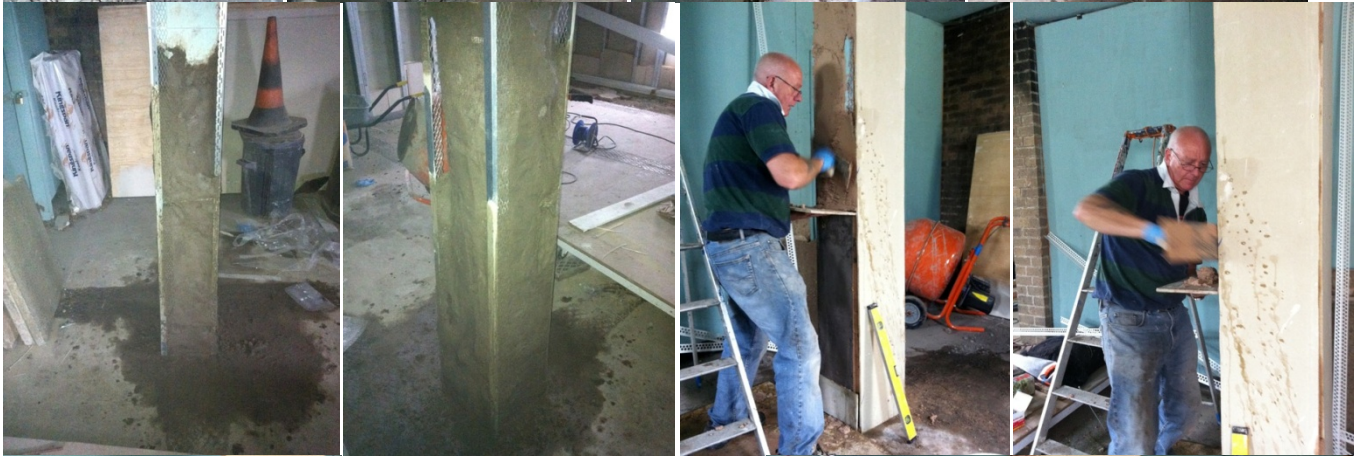
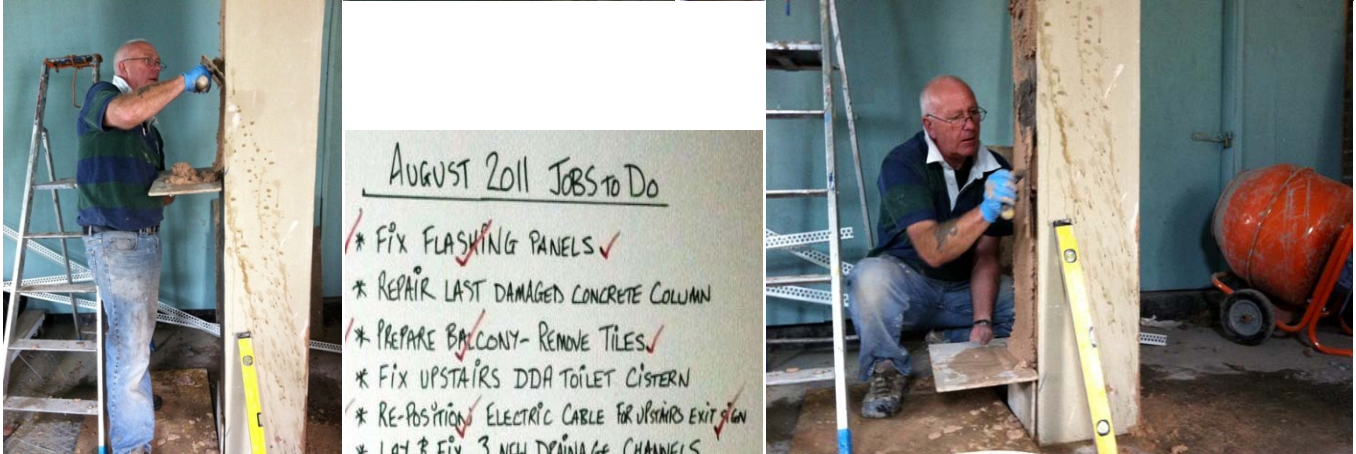
The final 'Column' to be repaired was scheduled for late August 2011 completion. As in most cases (But not all) our Scheduled Work Programme was once more on target with this repair. Which is really good timing as we are coming close to the next stage of work to the lower-ground floor area. The floor is to be insulated with 70 millimetres of thermal insulation and filled (on top of the Insulation) with self-levelling screed cement (another 70 millimetres)
